Investigating the Ability of Riparian Buffer Zones to Filter Nonpoint Pollution Sources Wyatt Stouffer Environmental Science Program

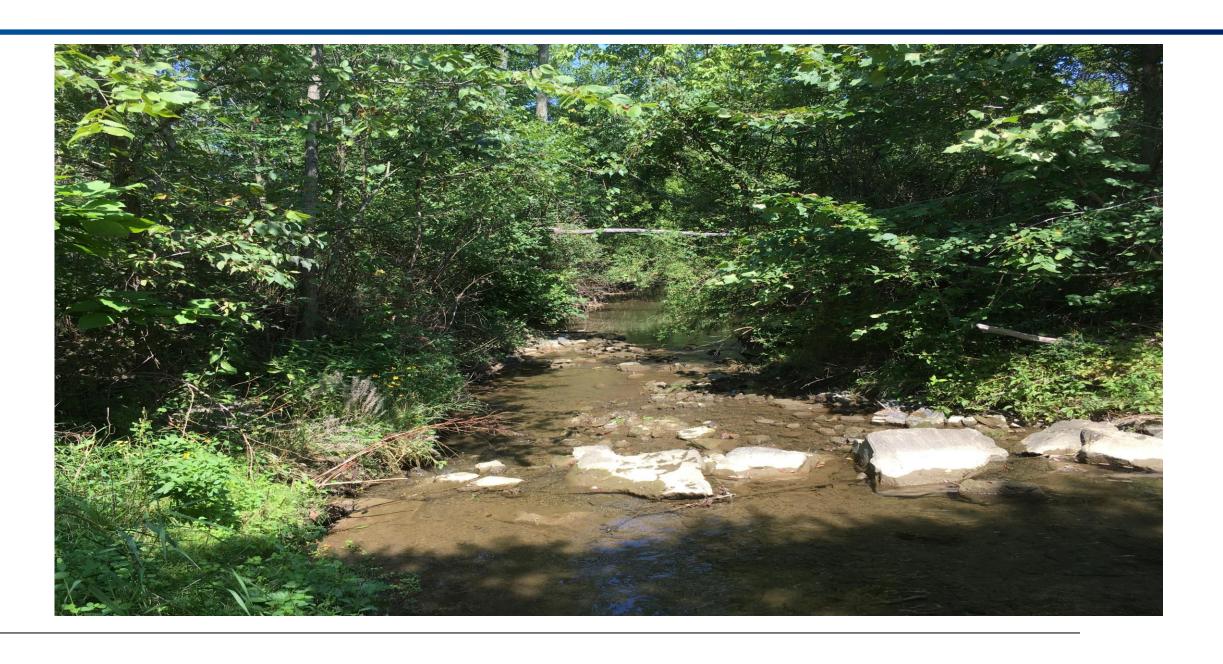
Site	Vegetation	Detection Time (min)	Max Concentration (µg/L)	Residence Time (min)
Site	vegetation	Dettection Time (mm)	(µg/L)	Restucitee Hille (IIIII)
MRD-R	Forested	6.5	7.6	15
MRD-L	Forested	8	27.8	14
MRU-R	Unforested	5.5	16.4	24
MRU-L	Unforested	6	54.8	17
Site				
0	10		30 40 amine WT Detected (µg/L ■ MRU-L ■ MRU-R	-)
Figure 2: Graph depicting the total concentration of Rhodamine WT detected at the four experimental locations within Monastery Run.

There were several differences in the pollution mitigation behavior of the two riparian zones that may be related to the variations in their characteristics. While the temperature differences between sites were not considered significant, the range of temperatures noted during these experiments may be of significant consequence to macroinvertebrate populations residing within the stream. The pH levels at both sites were slightly alkaline and are currently not a threat to the aquatic populations. Turbidity readings were consistently higher at the upstream site, indicating that the lack of vegetative cover is resulting in the erosion of stream banks at a greater rate than at areas of higher vegetated cover. The channel morphology of the two selected sites was similar, showing little variation in stream width, depth, and flow between the two sites. However, the channel characteristics showed significant differences in bank slope, riparian width, and vegetation cover. Two key differences were present between the data collected at the upstream and downstream sites for the Rhodamine WT and sodium nitrate experiments. These differences include how long it took for the experimental solution to be detected and the difference in the concentration of simulated pollutant present at each site. The longer time to detection and lower tracer concentrations at the downstream riparian buffer indicated superior pollution mitigation performance.
